YOUR INSPECTION REPORT

Total Inspection Solutions
Bob Petrillo
570 955-6299
bob@totalinspectionssolutions.com
www.totalinspectionssolutions.com

RE: Report No. 1778

on: Wednesday, January 31, 2018
Home Inspection

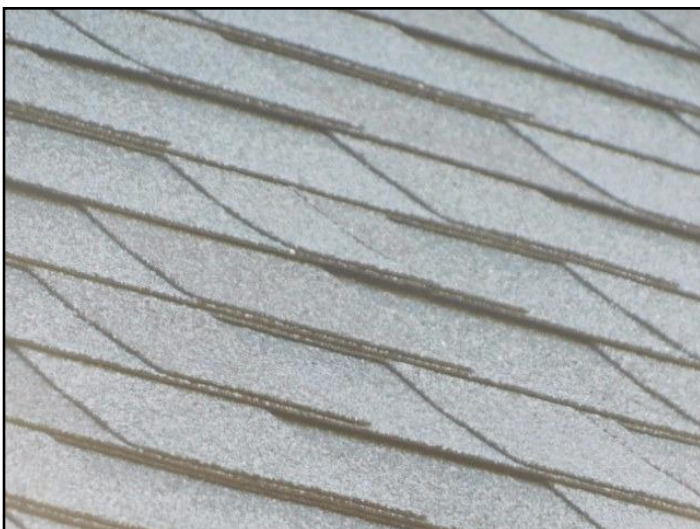
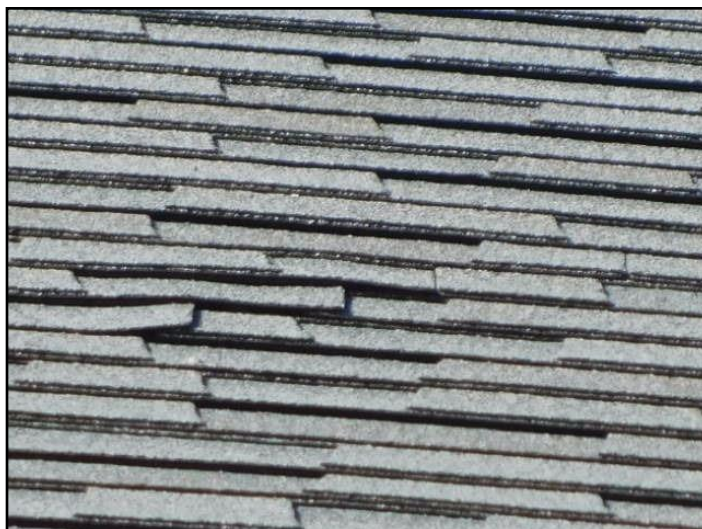
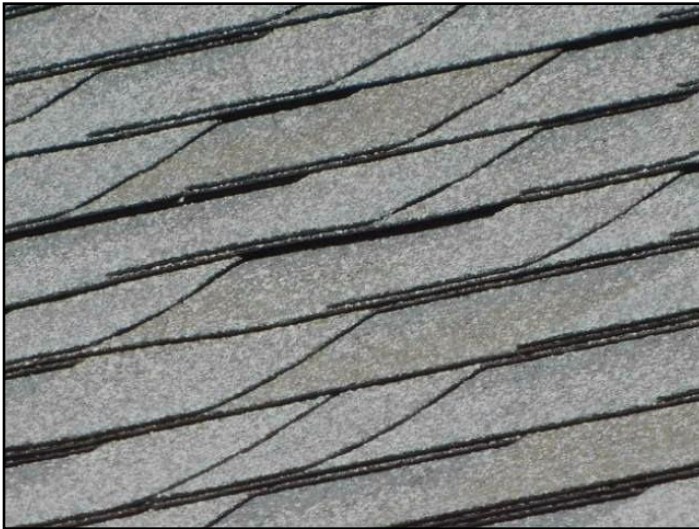
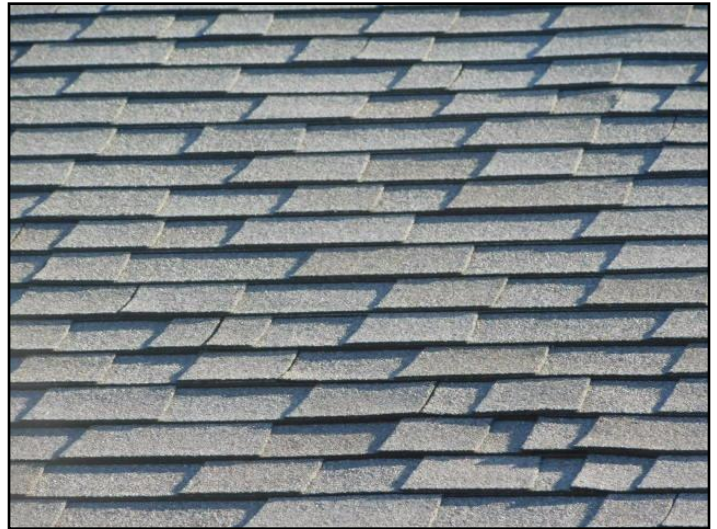
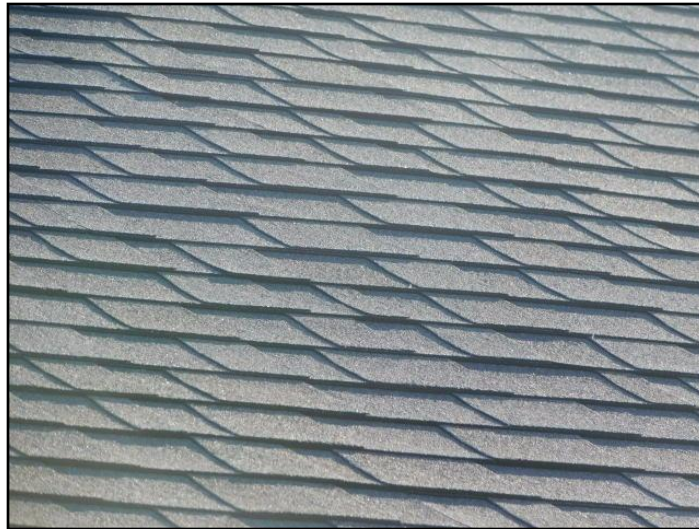
There are no recommendations for the main roofing material at time of inspection. It is reported to be between 8-9 years old and is architectural shingle with a typical life span of 30-40 years and it is showing signs of typical wear and tear.. I do recommend monitoring the material and inspecting annually for possible debris, moss and raised fasteners which can shorten the life span of the roofing material.

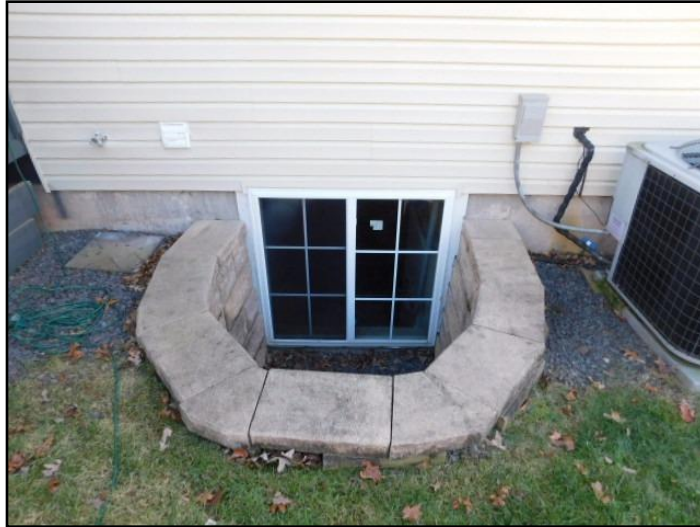
2. Condition: • There is a window well located in the rear of the home that looks to be missing any type of drainage which can allow excess moisture to penetrate the basement foundation. I recommend installing a window well cover to protect against excess moisture pressing against the masonry block and adding to any moisture issues present in the basement of the home.

6. There is a window well located in the rear...

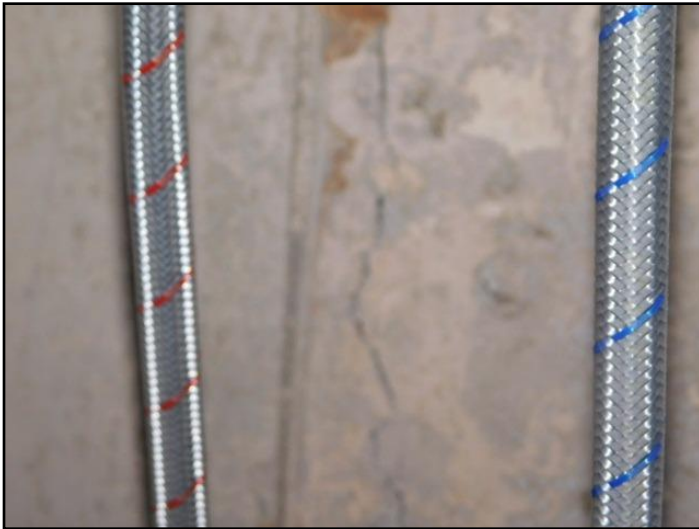
There are some typical settlement cracks in various spots along the foundation of the home and garage which should be repaired as this can allow excess water to penetrate the interior, I recommend repairing the cracks with masonry caulking and monitoring for any additional cracking that may occur from future settlement of the home.

8. Typical minor cracks

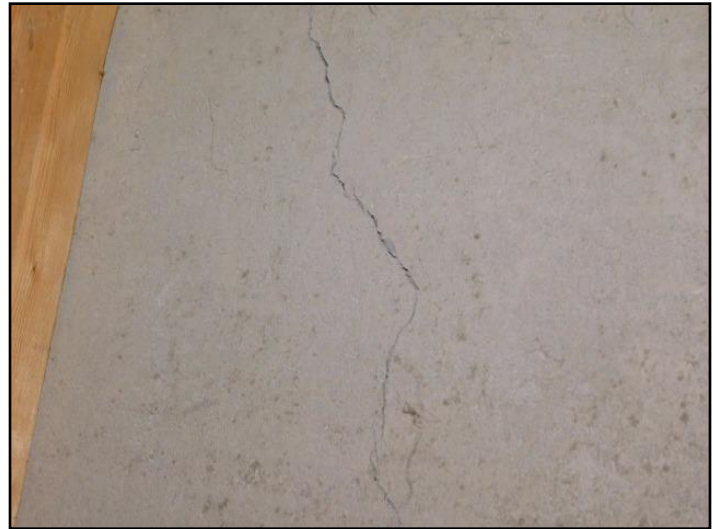
9. Typical minor cracks

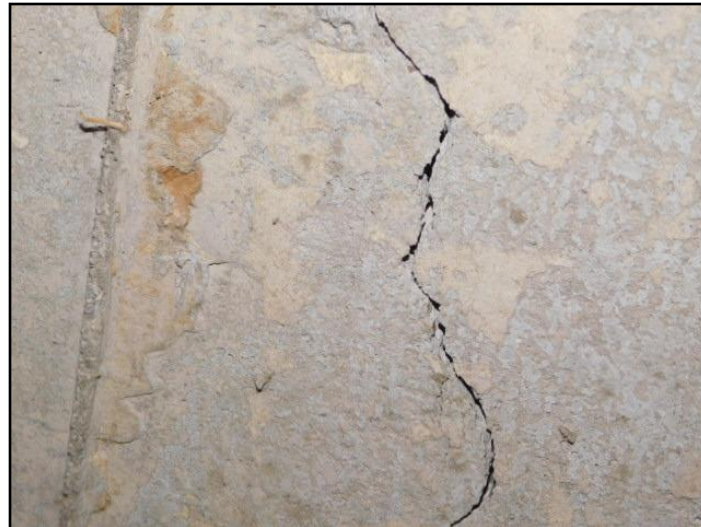
10. Typical minor cracks

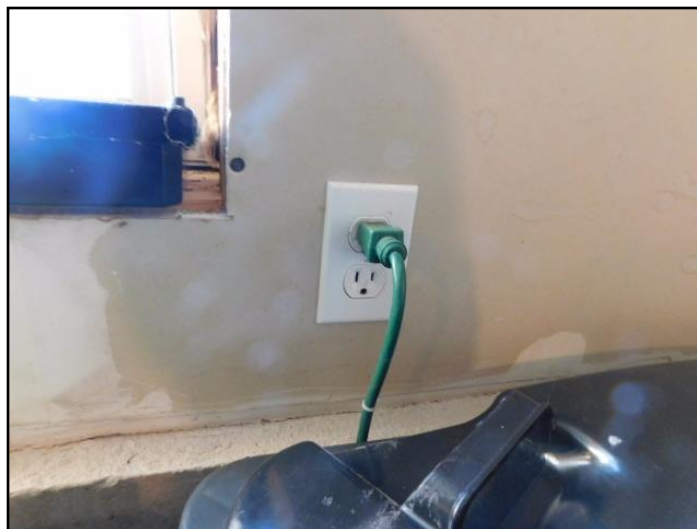
The building codes have changed since the home was built and there should be some updates done on the electrical system for proper safety in the home. There should be GFCI outlets added on various outlets in the garage as all garage outlets should have GFCI protection... I recommend replacing the outlets by a licensed electrician for proper electrical protection in the home.

12. No GFCI/GFI (Ground Fault Circuit...

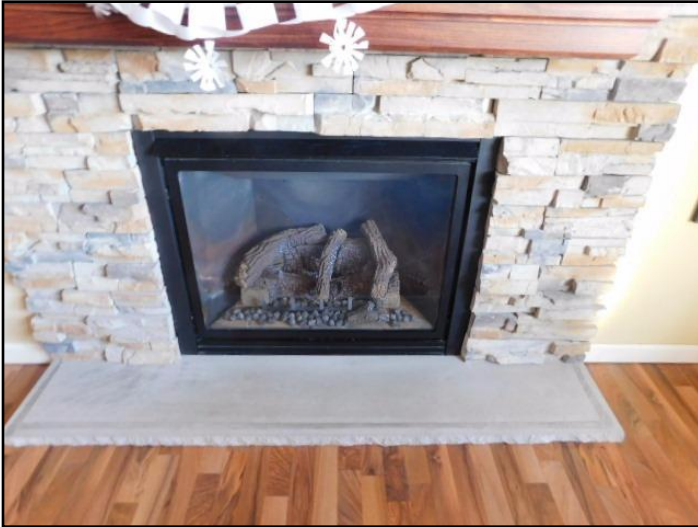
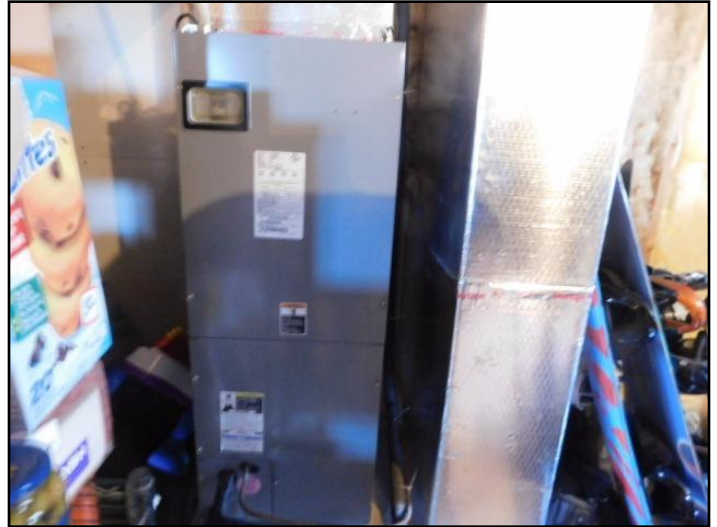
There are no heating recommendations for the home as the hot air furnace and propane fireplace were functioning normally at time of inspection., I do recommend inspecting and servicing annually to avoid future problems with the system.

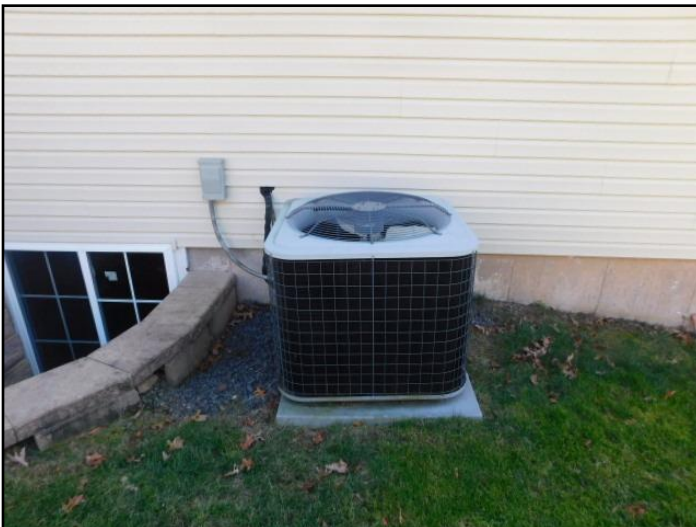
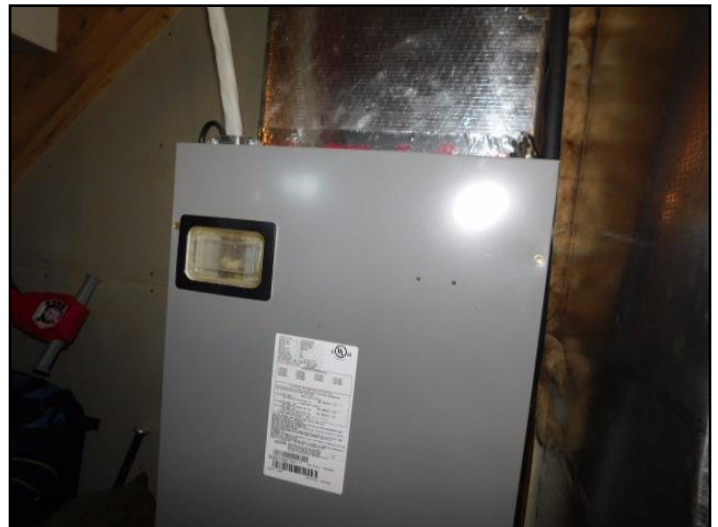
There are no cooling recommendations for the home as the central air unit operated normally at time of inspection. I recommend having the unit serviced before using for the summer season.

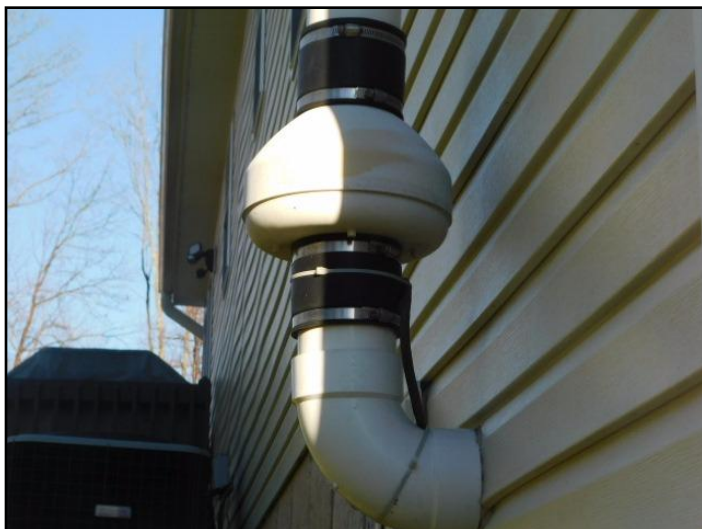
21. Other

The home has a radon mitigation system in place in the rear exterior and garage area which is making a loud vibration into the rear master bedroom that may make it hard to sleep. I recommend having a radon mitigation company further evaluate the radon fan and piping and repair or replace as needed for proper noise control in the home.
